FATIGUE CRACKING OF RIVETED STEEL TIED ARCH AND TRUSS BRIDGES

WA-RD 447.1

Final Report
March 1998

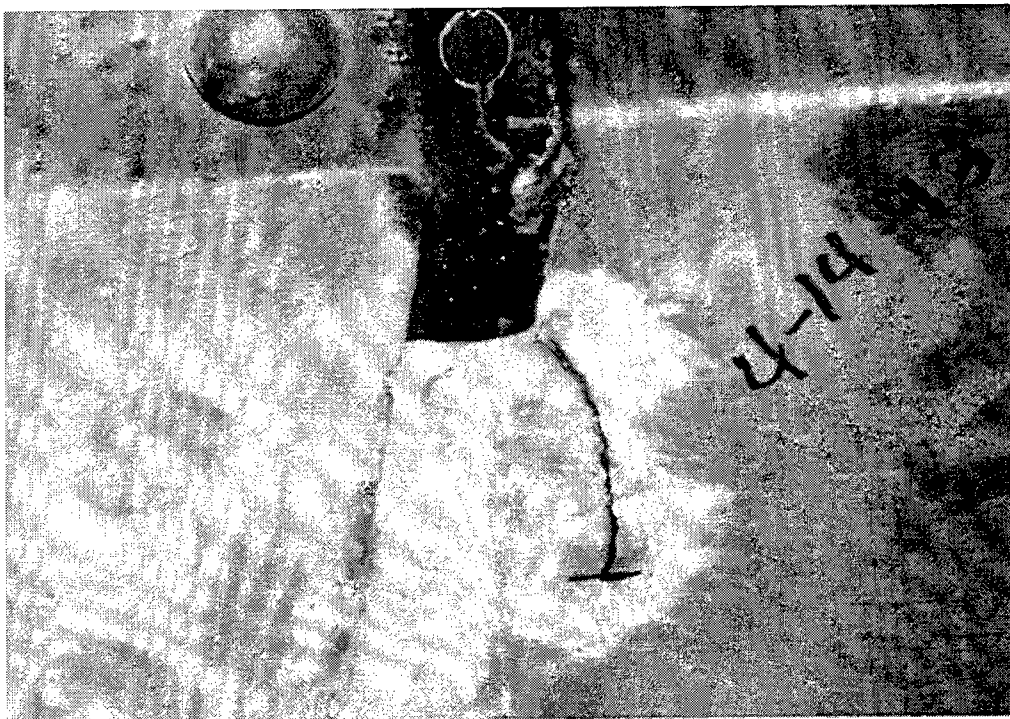
Figure 3. Crack Starting at Stringer Cope and Progressing into Web

larger cracks, bolts have been placed in the holes with or without clamping plates, and they have been tightened to induce a compressive stress at any potential crack tip to reduce the potential for further cracking. Other stringer to floorbeam connections have sustained cracking through the web angle, but this is not the most common crack location for these structural details.

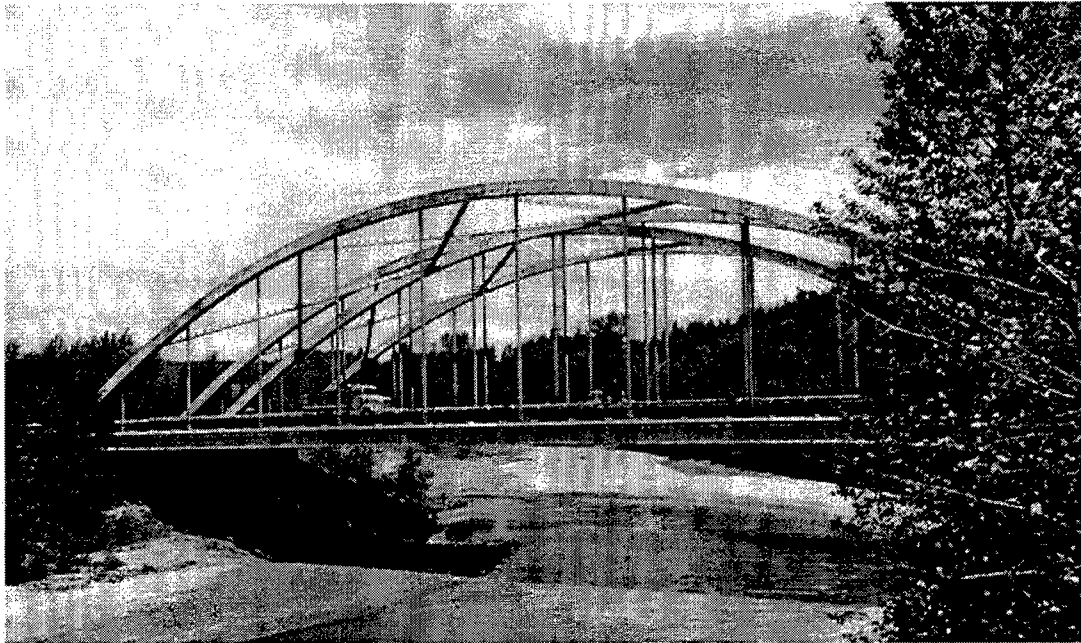
Figure 8. Steel Tied-Arch Bridge for the Southbound Lanes of Interstate 5
Crossing the Toutle River

The Toutle River Bridge is 92.66 m long, with 11 bays in the arch and floor system. Each bay of the floor framing has seven stringers, which are 2.29 m on center and have shear connectors distributed over their length. The arches are 16.75 m apart center to

center. There is no skew in the structure, and the arch and deck system are symmetric. The north end is pinned, and the south end is movable. The bridge is known to be flexible and lively under truck traffic, and fatigue cracking of the floorbeam web at the floorbeam-to-chord connection has occurred at all interior floorbeam connections. This type of cracking is illustrated in Figure 5. In addition, three of the web angles at these same floorbeam-to-chord connections have exhibited cracking. In 1989, these floorbeam to chord connections were repaired. The top flanges of the floorbeams were connected to the top flange of the chord by a flange plate to eliminate distortion of the connection. Since that date, crack initiation has moved down the web of the floorbeam at the stringer-to-floorbeam connection.

The two bridges selected were the west (southbound), three-span, continuous steel truss bridge crossing the North Fork of the Lewis River, as shown in Figure 7, and the west (southbound), tied-arch bridge crossing the Toutle River, as shown in Figure 8. They were approximately 50 km apart, and both bridges were in the southbound lanes of I-5. This assured that the two bridges would have similar truck traffic and were close enough that interaction and communication between the researchers working on the two bridges would be feasible. At the same time, all modes of cracking described earlier, except the chord cracking illustrated in Figure 4, were seen on these two bridges, and they also clearly illustrated the differences between the tied-arch and truss bridge behavior.

In the abutment floorbeams of the Toutle River Bridge, the abutment floorbeam was directly connected to the chord from the original construction with a flange plate. Two of these riveted flange plates have experienced serious fatigue cracking and have required replacement. Figure 9 illustrates the locations of cracking noted in the Toutle River Bridge.
